DOI: 10.17512/bozpe.2020.2.08

Construction of optimized energy potential
Budownictwo o zoptymalizowanym potencjale energetycznym

Design and assembly errors in the realization of post-and-beam glass facades

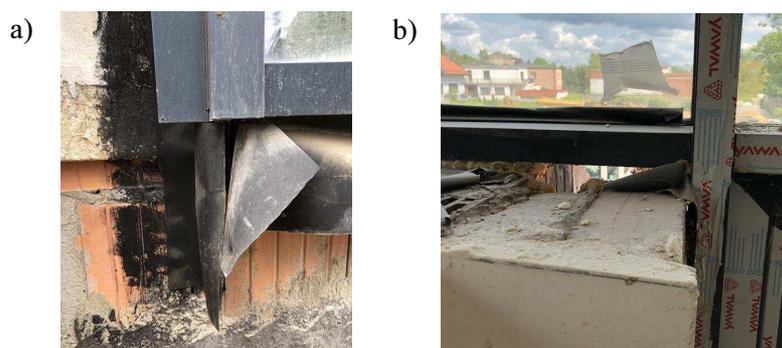
Careless installation of the EPDM membrane. The membrane, commonly known as an EPDM “apron”, is a form of sealing of the curtain wall structure at the connection with concrete and masonry elements. It protects against moisture while allowing it to evaporate from the space between the building structure and the aluminum profile. Incorrect installation is manifested by the apron falling off the profiles or the building structure (usually no glue) or failure to maintain the tightness between the apron strips. Lack of careful installation results in the loss of water tightness of the connection. Sometimes even the thermal insulation of the connection is omitted (Fig. 2a).

Fig. 2. Errors in the connection of the facade with the masonry elements: a) careless installation of the EPDM membrane, b) insufficient details at the interface with the wall (Photo: K. Chęciński)

Incorrect solutions of details in critical places. The construction of the curtain wall requires special attention to details such as the connection of the curtain wall with the ceilings, and the end of the facade at the bottom and top. Errors in this regard occur frequently and result in deterioration of water tightness and the formation of thermal bridges at the edge (Fig. 2b).

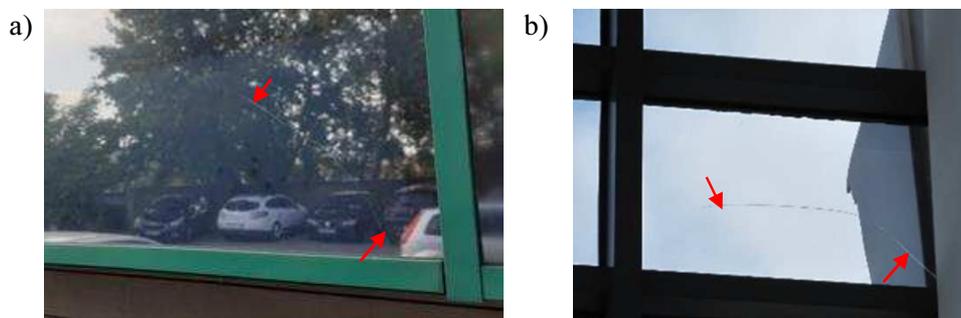
Incorrect support of filling elements. This is a mistake that is often made because of the popular opinion of a minor requirement. In principle, the beams are used to maintain a constant distance between the posts, but their other, equally important function is to transfer the weight of the filling to the posts. Thus, the uneven distribution or lack of the glass washers may result, firstly, in an uneven load on the posts, and, secondly, in a glass breakage caused by large local stresses in the area of the glass-washer interface. It is usually an initially small crack propagating from the edge of the glass pane in a direction close to perpendicular (Fig. 3a).

Wrong dimensions of fillings. Usually the sizes are selected automatically by programs dedicated to a given system, hence the number of errors is limited. Nevertheless, for example, in the case of the need to replace the panes or due to manufacturing errors in the spacing of posts and beams, the dimensions of the fillings may not be properly adapted to the real structure. If the glass is too shallow in the post profile, it may cause leaks. Too deep embedding of the glazing can lead to thermal cracks usually propagating from the side edge of the glass unit (Fig. 3b).

Fig. 3. Cracks in the fillings caused by: a) incorrect support of the glass panes (Photo: Z. Respondek), b) too deep setting of the IGUs (Photo: K. Chęciński)
