Construction of optimized energy potential
Budownictwo o zoptymalizowanym potencjale energetycznym

Restoring historical fenestration to normalize physical parameters of the microclimate of premises in historical buildings

In 2018, the authors had the opportunity to take part in developing recommendations for the improvement of fenestration (windows and covering) of the main building of the State Museum of Fine Arts in Moscow (Documentation prepared by the Federal State Unitary Enterprise; Scientific and Technical Report 2018a; 2019b; Spiridonov, Umnyakova, 2019a; 2019b). The building, designed by architect Robert I. Klein, was opened in 1912. The windows on the first floor and the translucent covering, created by the famous Russian engineer Vladimir G. Shukhov, has not changed since the construction of the museum (Fig. 1). Many elements have not been repaired since the commissioning of the building more than 100 years

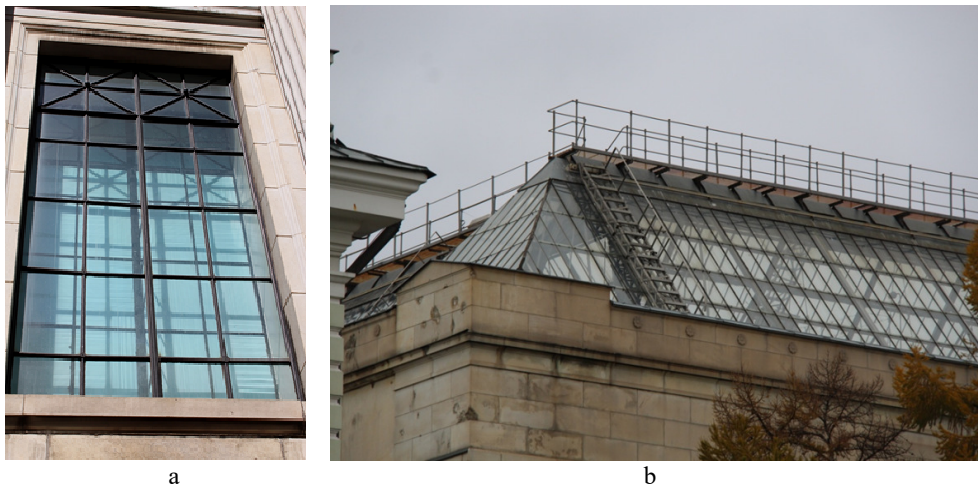
Fig. 1. Windows (a) and skylight (b) at the Pushkin Museum of Fine Arts (*own photo*)

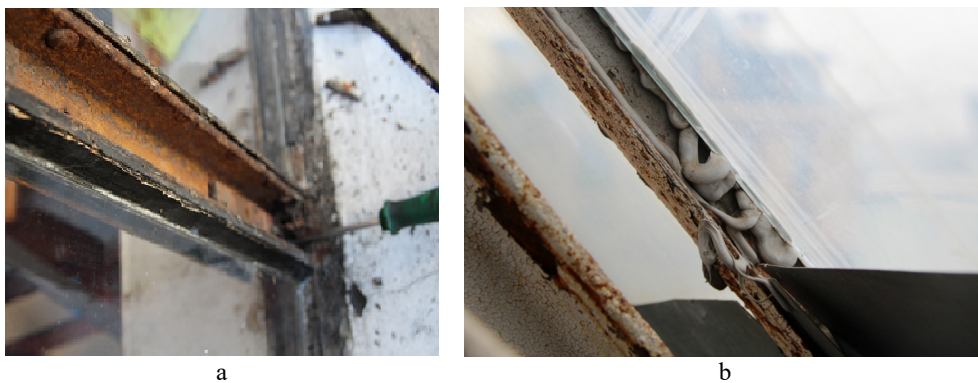
ago having lost their effectiveness (Fig. 2) and do not meet the requirements of modern building standards documentation.

Fig. 2. Current state of window elements (a) and translucent covering (b) in the Pushkin Museum of Fine Arts (*own photo*)

- the fenestrations are in very poor condition (in some cases non-repairable);
- the characteristics of the historical fenestration do not correspond to the current regulatory documents;
- condensation that forms on the internal surfaces of the fenestration during cold periods of the year adversely affect the safety of the structures;
- on the structures of the skylight facing the horizon, it is necessary to provide special sun-protection devices and curtains that diffuse direct sunlight.

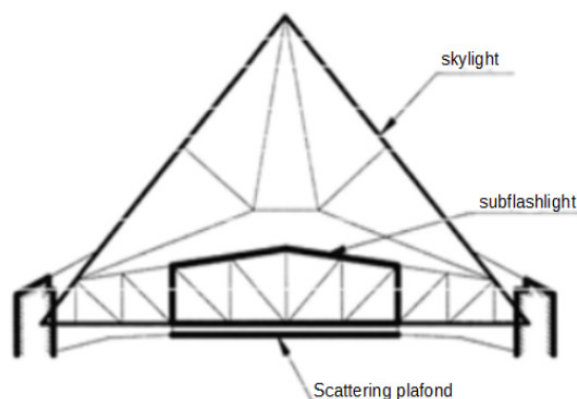
The fenestration consists of three contours (Fig. 3): the main skylight, subflashlight and scattering plafond.

Fig. 3. Diagram of fenestration of the Pushkin Museum of Fine Arts (*own study*)

At the moment, all the contours of the glazing are made from a single piece of glass mounted in metal T-shaped plates. All structures were installed during the construction of the museum at the beginning of the last century (some restoration work was carried out in the 1970s).

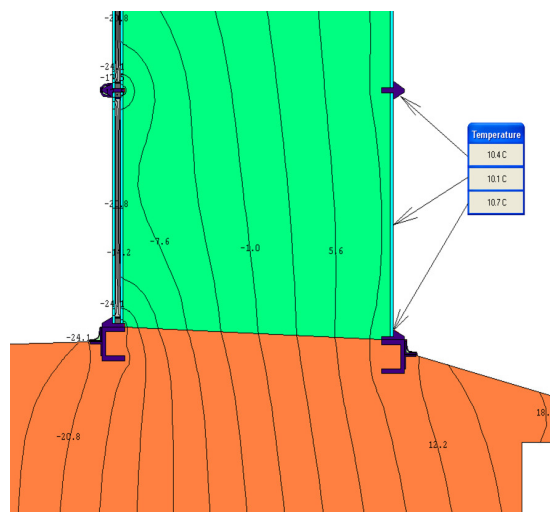
Option 5 – historical fenestration, but fenestration filling – single IGU (insulated glass units) window with an outdoor sunscreen and an internal low-E glass 4C3-10Ar-4И in an external metal frame and heat-reflecting glass with a soft low-emission coating with an increased abrasion resistance 6 mm thick in an internal metallic frame with an internal metallic frame 6 mm thick. Temperature distribution is shown in Figure 4.

Fig. 4. Temperature distribution over the inner surface of the lower part of the fenestration, manufactured according to Option 5, with $t_{\text{H}} = -28^{\circ}\text{C}$ (*own study*)

The reduced resistance to heat transfer of this option (while preserving historical steel frames) is $R_0 = 0.58 \text{ m}^2 \text{ K/W}$ ($U = 1.72 \text{ W/(m}^2\cdot\text{K)}$). At the same time, we were able to provide temperatures on the internal surfaces of fenestration, which ensure that condensation does not occur under all possible climatic conditions in the Moscow region.

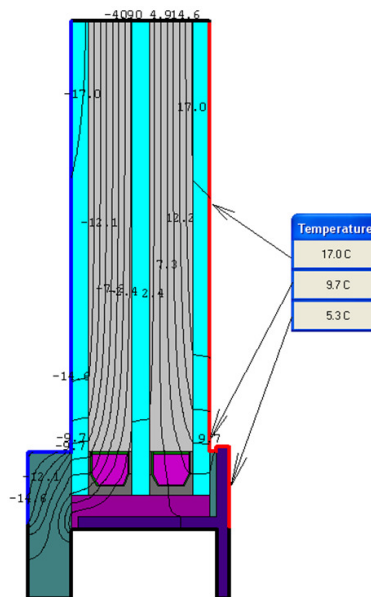
When preserving the historical structures, Option 7 was the best – the existing metal frame glazed with a triple IGU 4И-10Kr-4-10Kr-4И (4И – low-E glass: PLANITHERM 4S, emission coefficient $\varepsilon = 0.013$, warm edge TGI); on the side of the under-roof space, a 10 mm thick foam polystyrene overlay was installed on the brand (Fig. 5).

The heat transfer resistance of this design is $R_o = 0.92 \text{ m}^2 \text{ K/W}$ ($U = 1.09 \text{ W}/(\text{m}^2 \cdot \text{K})$), while ensuring the absence of condensation on the metal parts of the translucent structure of the subflashlight.

Fig. 5. Temperature distribution over the inner surface of the glazing of the subflashlight when using a IGU 4И-10Kr-4-10Kr-4И (*own study*)
